Vija Strupule

REFLECTIONS OF ANTIQUE ART IN THE
INTERIOR PAINTINGS OF RESIDENCES
AND MANOR HOUSES IN LATVIA.

THE SECOND HALF OF THE 18TH CENTURY – THE FIRST
QUARTER OF THE 19TH CENTURY

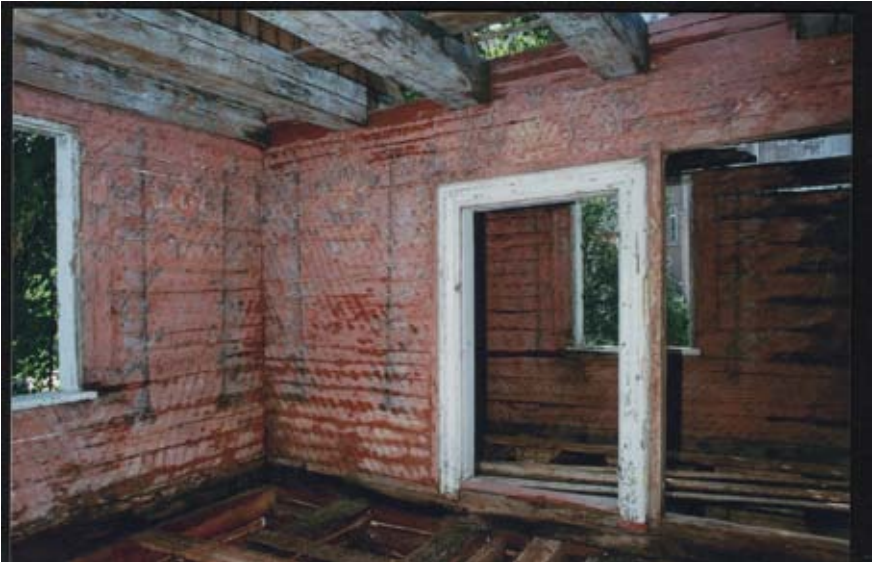
Fig. 1. Liepāja, 11/13 Baznīcas Street. Second floor painted colonnade on wooden beams. 1740s–1750s. Photo by Juris Zviedrāns, archives of the Architectural Investigation Group Ltd.

Finishes with painted colonnades in Latvian residential interiors have also been known since the Baroque age. Several such compositions from the 1740s and 1750s painted directly on timber constructions have been found in the Courland harbour city of **Liepāja** (Libau): **6 Kungu Street**¹³, **16 Kungu Street**¹⁴, **21 Bāriņu Street**¹⁵ and **11/13 Baznīcas Street** (fig. 1)¹⁶. Here column shafts are interlaced with gorgeous flower garlands and ribbons. However, the capital solution is mostly a free improvisation, only distantly resembling the classical order. It may even be replaced by such atectonic details as orbs or bizarre bundles of leaves. In sever-

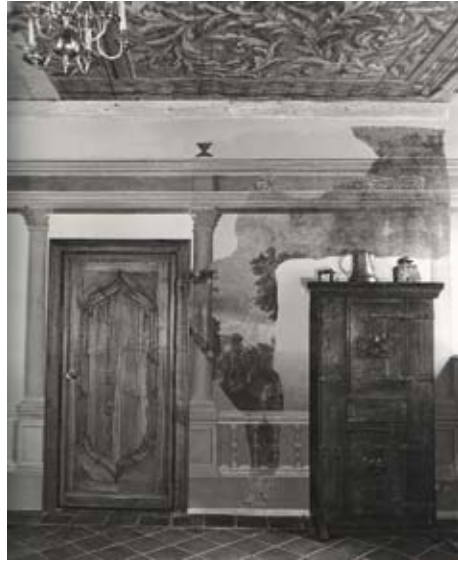
Fig. 2. Mentzendorff house. Rīga, 18 Grēcinieku Street. First floor colonnade painted on plaster. The 3rd quarter of the 18th century. Photo from the restoration documentation, compiled by Polish restorers in 1991.

In the third quarter of the 18th century, painted colonnades became a feature of residential interiors in **Rīga** as well. An intact and restored example of such an interior is located on the ground floor of the Mentendorff house (18 **Grēcinieku Street**, fig. 2). Here smooth column shafts are also interlaced with flower wreaths, but the dado between the column pedestals is filled with a painted balustrade. In this case, an unknown master had showed an understanding of a definite order system, because the columns are decorated with a capital similar to the Corinthian capital. The columns support an illusory painted entablature with floral ornamentation on the frieze. It is interesting that it is not located right beneath the ceiling zone, but considerably lower. Consequently, an illusion of an open colonnade standing in a city garden is created. In a small area there has also survived a landscape painting, showing a river or channel bank with houses visible through trees. In the foreground, a man in mid-18th century dress stands on a bridge with his back turned to the onlookers, watching together with the visitor to the

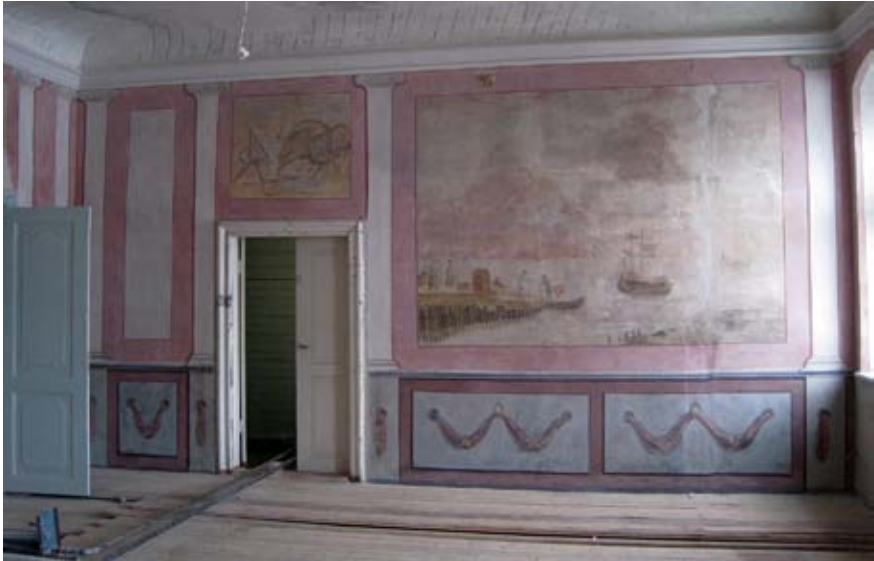
Fig. 3. Limbaži, 4 Burtņieku Street. Second floor colonnade painted on plaster, after conservation. The last quarter of the 18th century. Photo by Marina Mihailova, archives of the Architectural Investigation Group Ltd.

Evidence of the ambitious goals of a citizen of a Vidzeme town at the end of the 18th century in finishing his residence is provided by the painted interiors in **Limbaži** (Lemsal), at **4 Burtņieku Street**²⁰. The building was constructed between 1776 and 1798 as a private residence, and

its owner was the merchant Braunschweig²¹. Wall and ceiling paintings were first detected in 1988. Now they have been revealed, consolidated and partially restored in three places (fig. 3). In all of them, in a noteworthy professional manner, a romantic sea or southern landscape is depicted surrounded by illusory architectural framing. Both frame and colonnade systems are used here. Rectangular forms, panels ornamented with festoons in the dado zone, a reserved colonnade solution without previous-period-favoured flower garlands, as well as the lack of a luxuriant framing for the landscape panels reflect the presence of a Neo-Classical style. Pale pinks, bluish, greyish-white hues and marbling effects were used in the colouring.

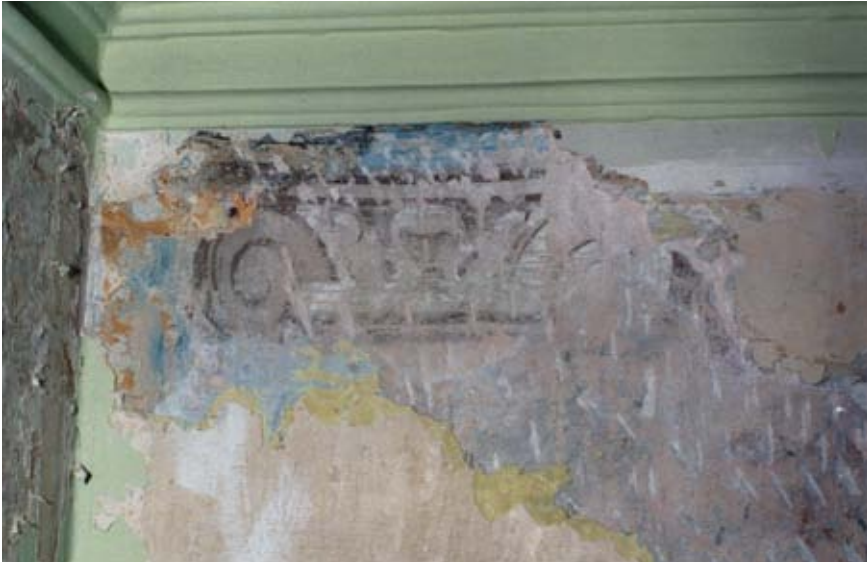
Fig. 4. Riga, 6 Lielā Pils Street. Painted capital of a column. Late 18th century. Photo by Juris Zviedrāns, archives of the Architectural Investigation Group Ltd.

A painted colonnade in the Neo-Classical fashion, lacking the playful rococo touch, was revealed in a residence in **Rīga**, at **6 Lielā Pils Street**²², designed in 1795 by Christoph Haberland. The painting is located in a second floor hall (fig. 4). Entering the room at the end of the 18th centu-

ry, one would have had the impression of entering a column-embraced pavilion, beyond which an azure sky and possibly some natural landscape was revealed. Illusory painted architecture divides walls: the base, treated as a low stone wall or pedestal with laurel leaf festooned garlands on panels, and fluted columns with Corinthian capitals, 'carrying' a real cornice. Beneath the cornice, possibly, a painted drapery was hung. In the areas between the columns, sculptural characters of fashionable women of the period, painted in full figure, are standing on socle pedestals. The painting was carried out in off-white: a white grisaille technique on a pale blue background with distempers. The limited opening volume and missing painting layers, as well as a change of rendering in separate areas, do not allow for complete reconstruction of the painting composition. The colour layer has survived better at the bottom and in the corners of the wall, but the central plane is in places fully cleared away. Only a preparatory painting drawing contour is visible in this zone – the outline of a lady's figure. Therefore, even though the irreversible loss is regrettable, we have an opportunity to observe the painter's work process. As often happens, the initial painting of the ceiling plane is gone.

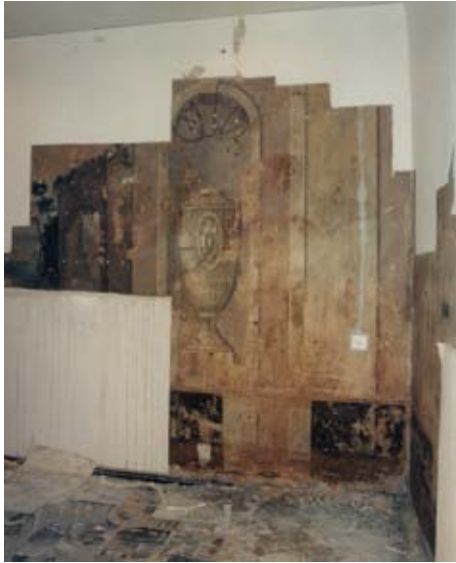
Fig. 5. Riga, 11 Kalku Street. Wall painting on plaster. Late 18th century. The painting was covered up before it was entirely uncovered. Photo by Juris Zviedrāns, archives of the Architectural Investigation Group Ltd.

Wall paintings in **Riga, at 11 Kaļķu Street**,²⁶ date back to the end of the 18th or the beginning of the 19th century (figs. 5, 6). The Architectural Investigation Group carried out research there in 1997. Before the beginning of practical work on the site, even professionals with considerable experience were unable to predict the existence of interior finishing older than the second half of the 19th century in the building, which was totally rebuilt in 1902. Serious alterations also occurred in the mid-19th century. Therefore, it seemed unreasonable to search for any older remains in the building. However, when probing of the painting took place in one of the rooms on the second floor of the premises, pieces of painted landscapes and architectural details were exposed on two walls. The finishing had been executed with oil paints on plaster. It was the first finishing layer, which had been preserved in relatively good condition.

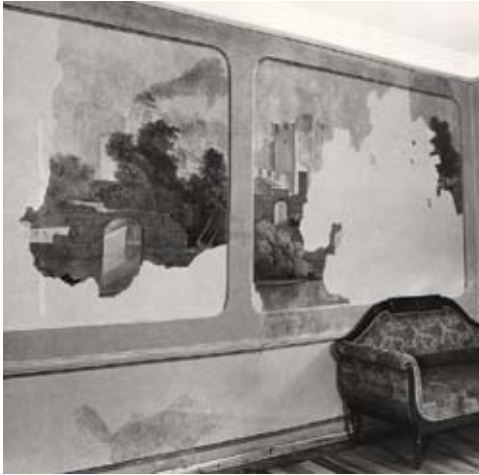
Fig. 7. Mentzendorff house. Riga, 18 Grēcinieku Street. Second floor wall painting with an Italian landscapes. Early 19th century. Photo from the restoration documentation, compiled by Polish restorers in 1991.

In a small area on the second floor, fragments with Italian landscape paintings have been restored (fig. 7).³¹ A simplified frame system version was used: a band-like base without panels and a smooth, undecorated frame with austere chiaroscuro contouring. The landscapes show southern city architecture embraced by trees, and the romantic feeling is deepened by

the ruined stone block mason-work bridges and walls in the foreground of the painting. Possibly, the interior is a result of the repairs of 1804, when the value of the property increased by 1600 thalers.

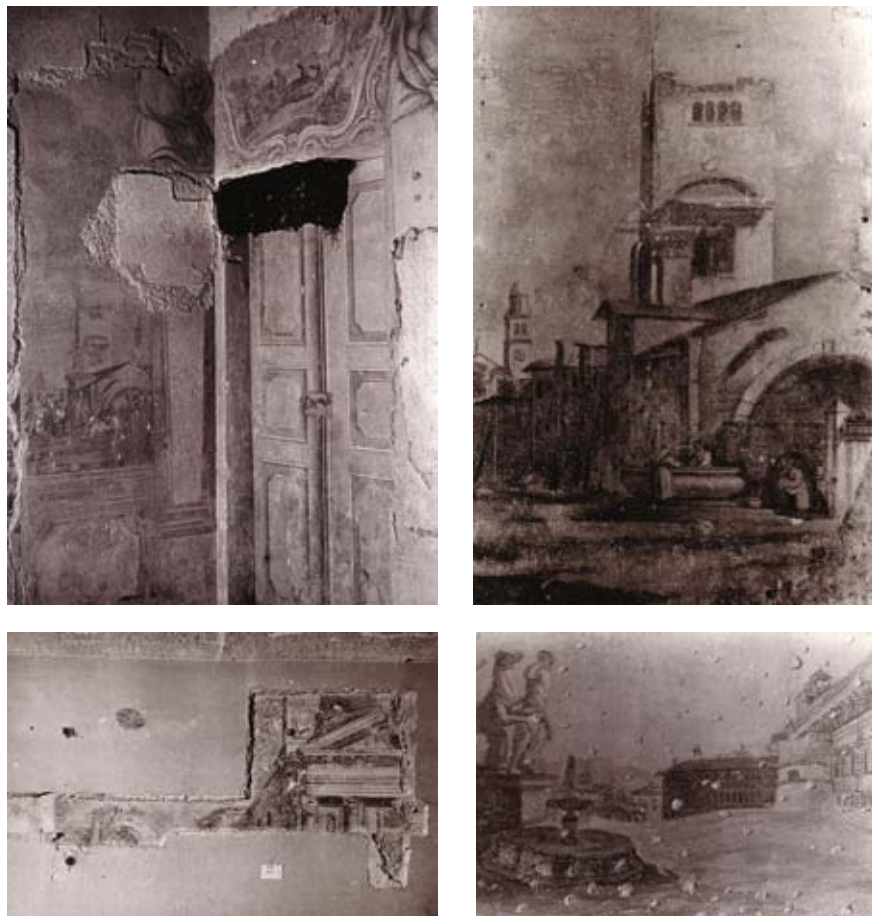
Figs. 8.–11. Krāslava Palace. Fragments of the wall painting. The 1760s–1770s. Photos from restoration documentation (1994) and Ieva Lancmane's *Krāslavas pils izpētes materiāli* (manuscripts in the Centre of Documentation of State Inspection for Heritage Protection of the Republic of Latvia).

Even though illusory paintings in Riga burghers' flats were pretty pompous, they were no more pompous than the typical manor house finishing. Outstanding examples of such pictorial art in Latgale are the **Krāslava** (Krasław, Kreslau, Kreslavka) **Palace** interiors, created in the 1760s and 1770s, possibly connected with the Italian master Filippo Castaldi (1734–1814) (figs. 8–11). Though no direct documentary confirmation has been found, both the painter's background and his connections with the family of the owner of the Krāslava manor, Count Plater, as well the style of the paintings point to the master's work on the decoration of the palace interiors.³² The painting composition on the wall of the ground floor hall consists of views of Rome and landscapes with staffage, enclosed in convincingly grisaille technique architectural framing:

dado, pilasters, herms and consoles (corbels). Rococo-style ornamentation was applied. The motifs in the landscape drawings have been identified as a direct borrowing from the engraving sheets of Giovanni Battista Piranesi. For example, the composition of the Palazzo Quirinale precisely duplicates Piranesi's etching "A view of the 'Monte Cavallo' Square", from the series *'Vedute di Roma'* (1748–1760). In other compositions, the author used details of separate Piranesi engravings, freely varying and

supplementing them.³³ Perhaps the painting of Constantine's Arch was ordered by the master in honour of the Krāslava Palace owner's father, Count Konstanty Ludwik Plater.

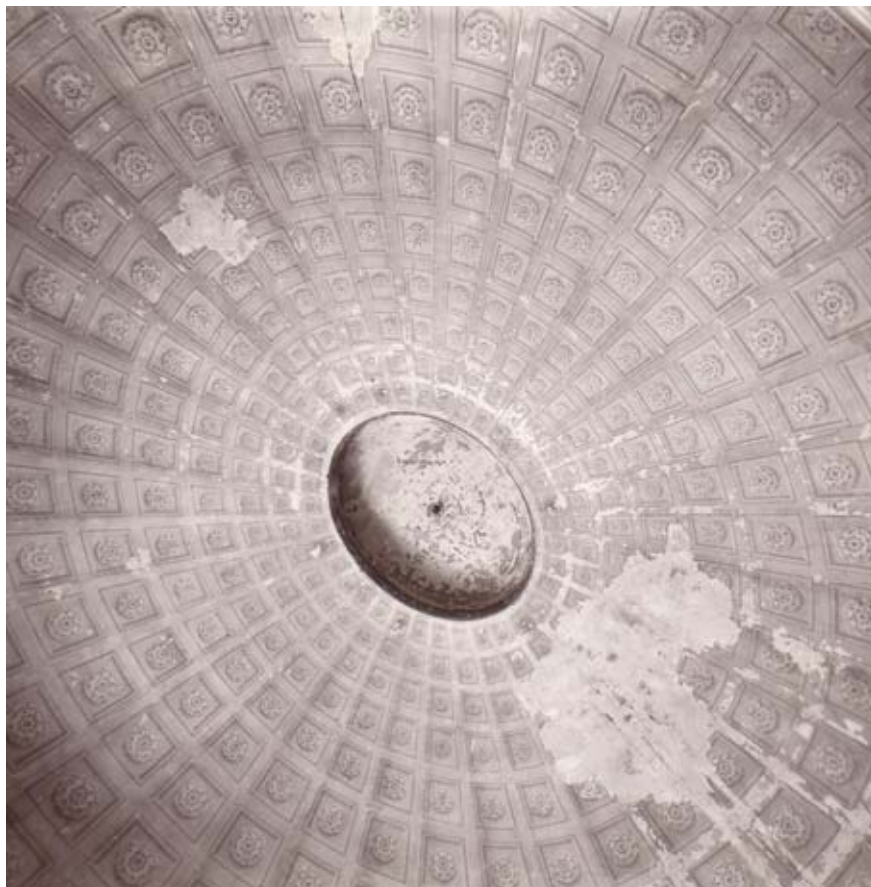
Fig. 13. Jaunauce manor. Fragment of the painted dome. Photo by Jānis Zilgalvis, 2001 (Centre of Documentation of State Inspection for Heritage Protection of the Republic of Latvia).

on the garden side of the building. Some black and white photographs showing illusory cassette paintings have survived. The solution of the composition with quadrature cassettes, decorated with rosettes, is close to the Eleja palace model. Another similarity is the rosette painted in the centre of the dome, which in this case is a bit stretched, being adapted to the oval plan of the room. Nowadays, there is a school located in the palace. The oval hall was rebuilt in the 1960s, and the space was divided into two levels. The dome painting was not saved.
